National Parks & Wildlife Service  
Tóchar Midlands Wetland Restoration Scheme

Fin Lough (Offaly)

**Fen Restoration Plan**

**Fen Restoration Plan**  
**Fin Lough (Offaly) SAC (000576)**

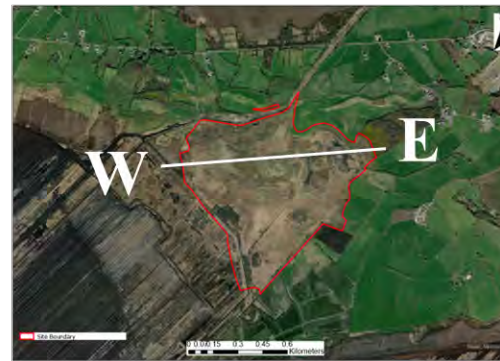
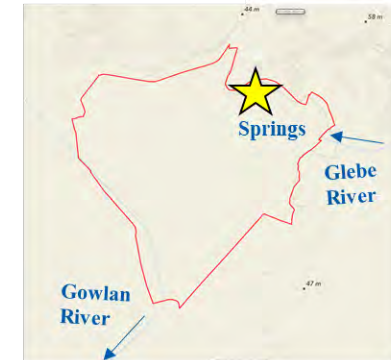
Figure 3-21: Conceptual Site Model of Fin Lough (Offaly)

Seepage percolation quag (WETMEC: 13b) & Ombrogenous bog (WETMEC 3)

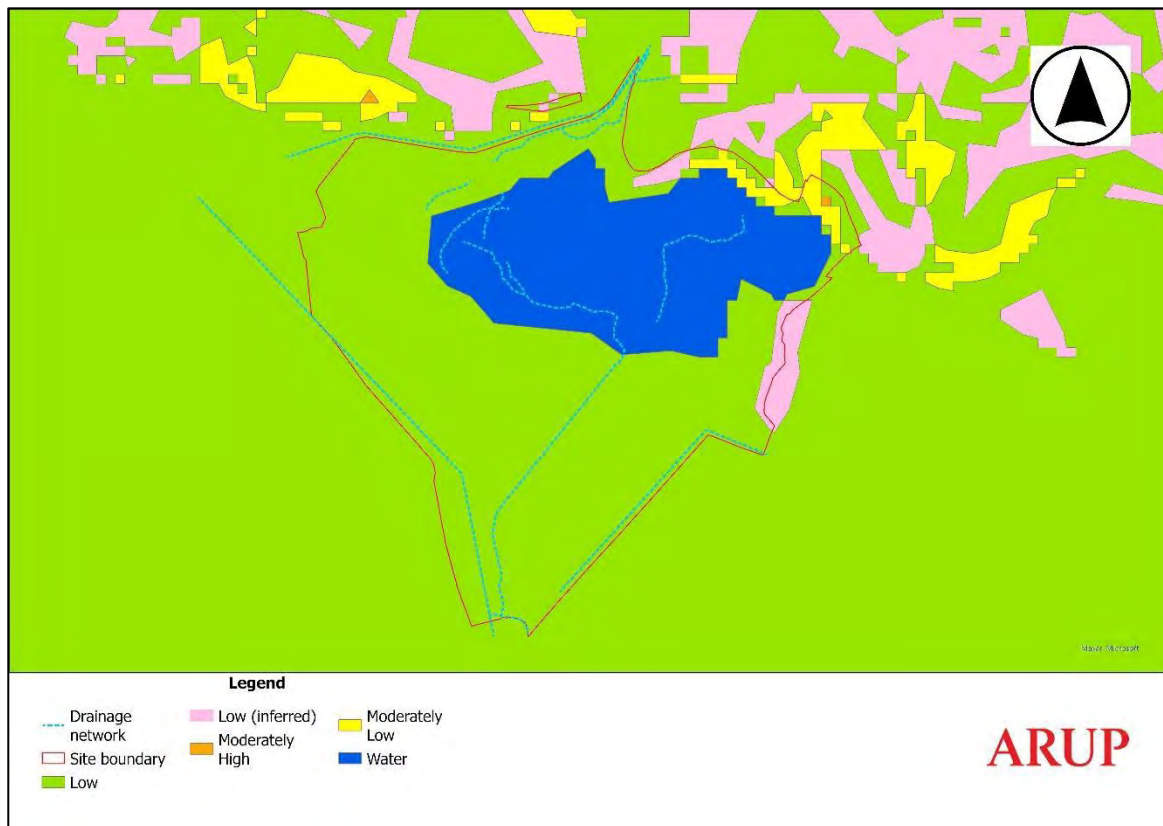
**Figure 7-1: Geological Survey of Ireland Landslide Susceptibility mapping for Fin Lough (Offaly)**

The GSI landslide susceptibility map for Fin Lough is presented in Figure 8-1. This highlights that there are no known historical landslides within the site, and the site is mostly classified as at low risk of landslide susceptibility. A pocket of moderately low landslide susceptibility is

located on the northeastern boundary of the site, however no restoration measures which require vehicle access or excavation are in this area.
