National Parks & Wildlife Service  
Tóchar Midlands Wetland Restoration Scheme

Lough Garr  
PFS Site No. 1004  
NHA 001812

**Fen Restoration Plan**

April 2026

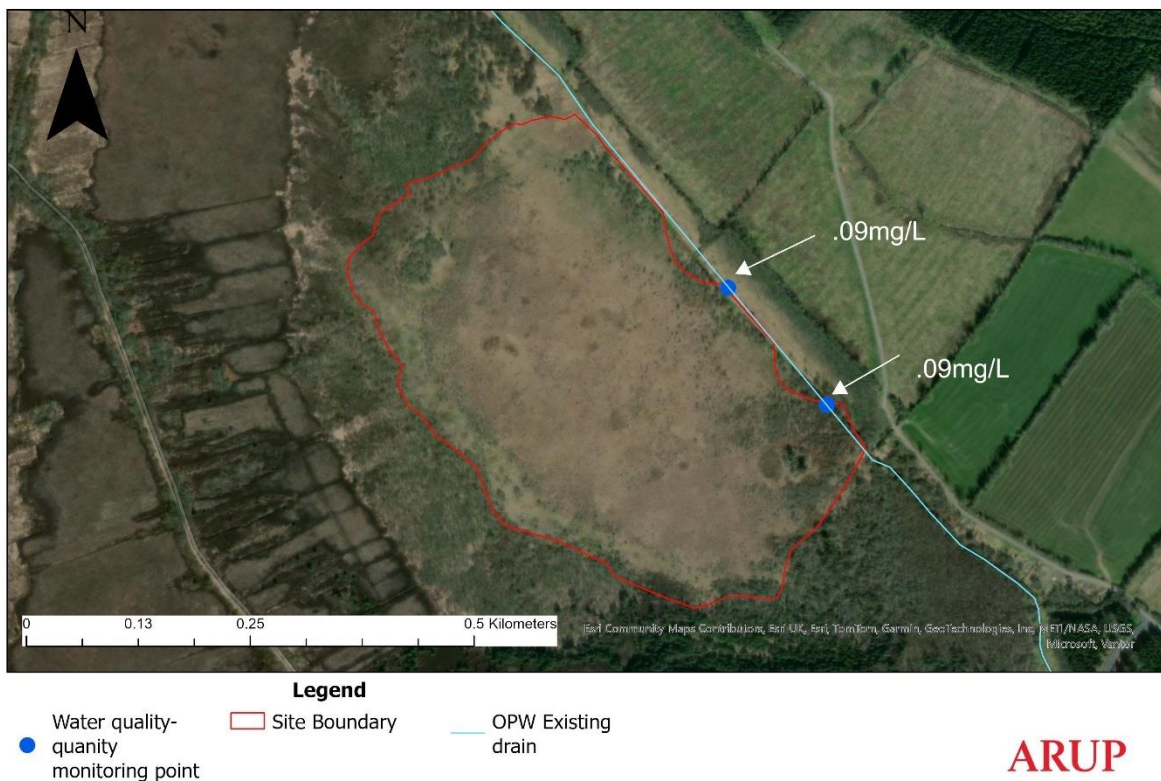
A potential source of nutrient enrichment across the site is the forest managed by Coillte in the northern part of the site boundary, agricultural activity and the presence of livestock. Phosphate concentrations ( $\text{PO}_4$ ) along the existing drain remained constant at 0.09 mg/L, below the good status environmental quality standard of 0.107 mg/L  $\text{PO}_4$  (0.035 mg/L  $\text{PO}_4\text{--P}$ )<sup>4</sup> (Figure 3-20). Further monitoring is required to assess seasonal variations of water quality in relation to upstream forestry activity.

**Figure 3-20: Monitoring results for Phosphate ( $\text{PO}_4$ ) at Lough Garr**

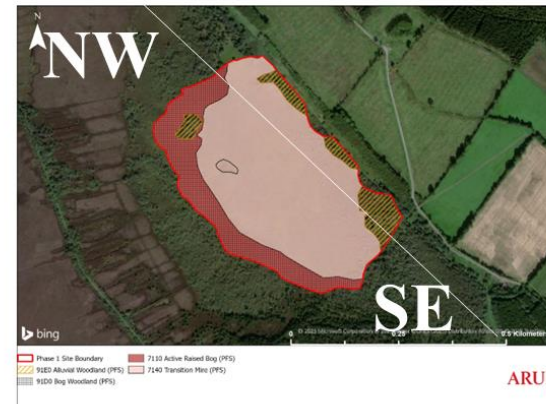
- The topography of the site is relatively flat, with higher ground along the boundaries and a slight depression towards the centre.
- The site is underlain by cutover bog peat and till derived from Lower Palaeozoic and Carboniferous sandstones and shales. Beneath these deposits lies a Locally Important Aquifer – Bedrock that is Moderately Productive only in Local Zones (LI). Groundwater flow is largely confined to the upper 15 metres, within the weathered and fractured bedrock zone. Recharge of this aquifer occurs mainly through rainfall infiltration.

WETMEC: 3: Buoyant Weakly Minerotrophic Surfaces ('Transition Bogs')

Figure 3-22: Conceptual Site Model (CSM) – Lough Garr

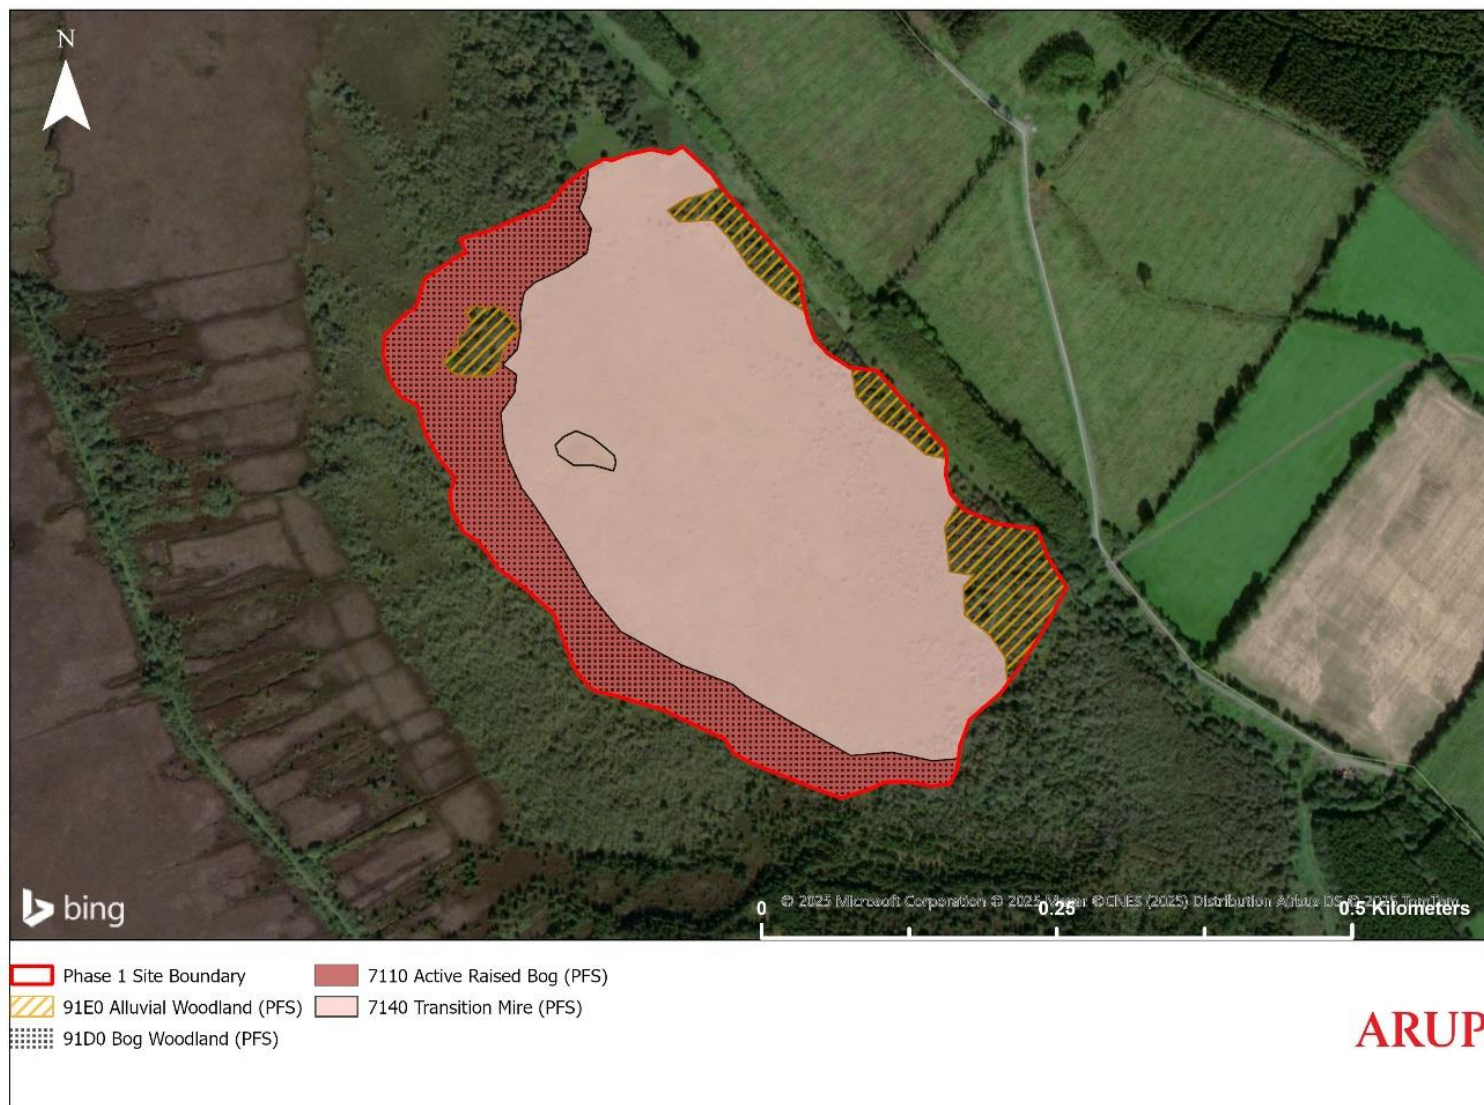
Figure 1: Site Habitat Map

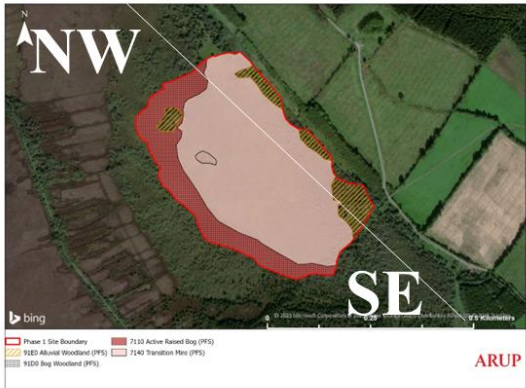
**Figure 2: Conceptual Site Model**

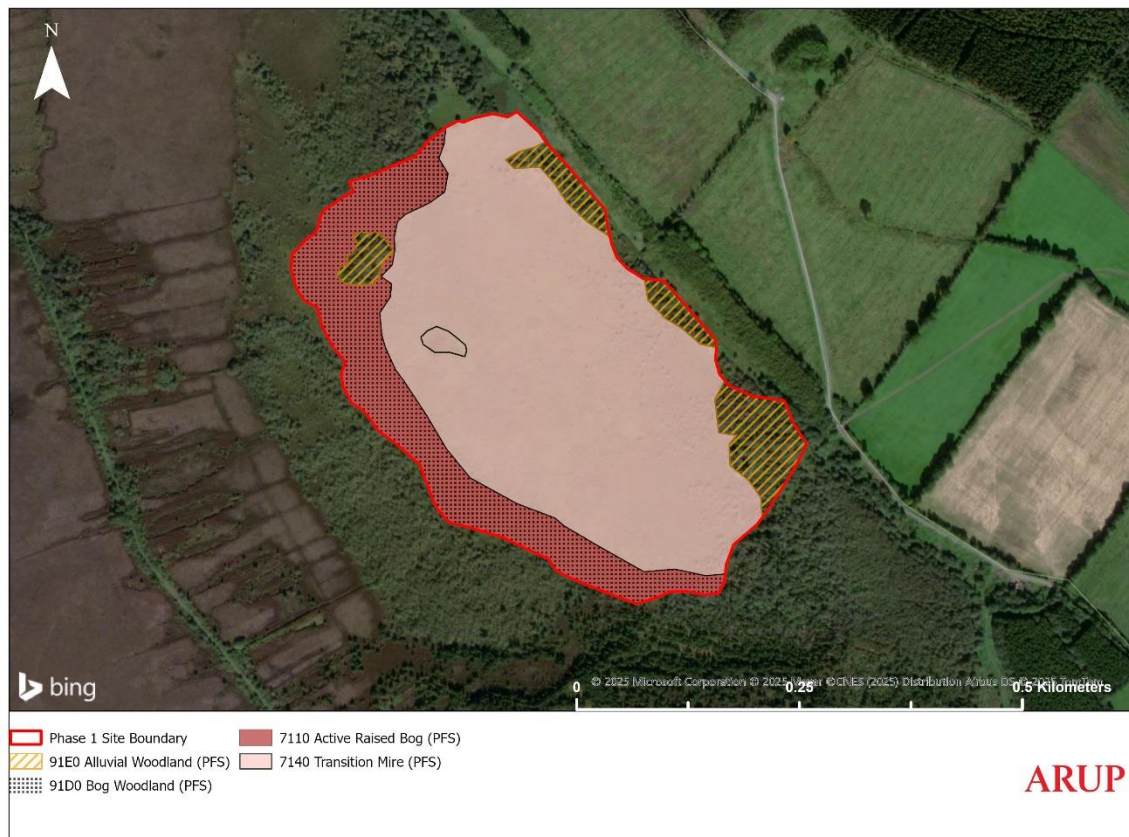
**B-1: Fossitt habitat types at Lough Garr**

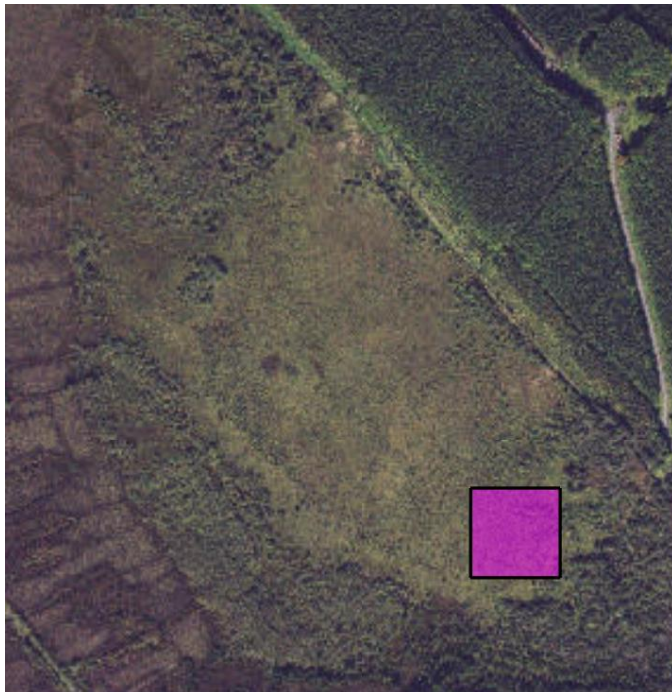
**Figure B-2: NBDC records of the protected rigid bog-moss *Sphagnum teres* within the boundary of the Lough Garr area in this FRP**

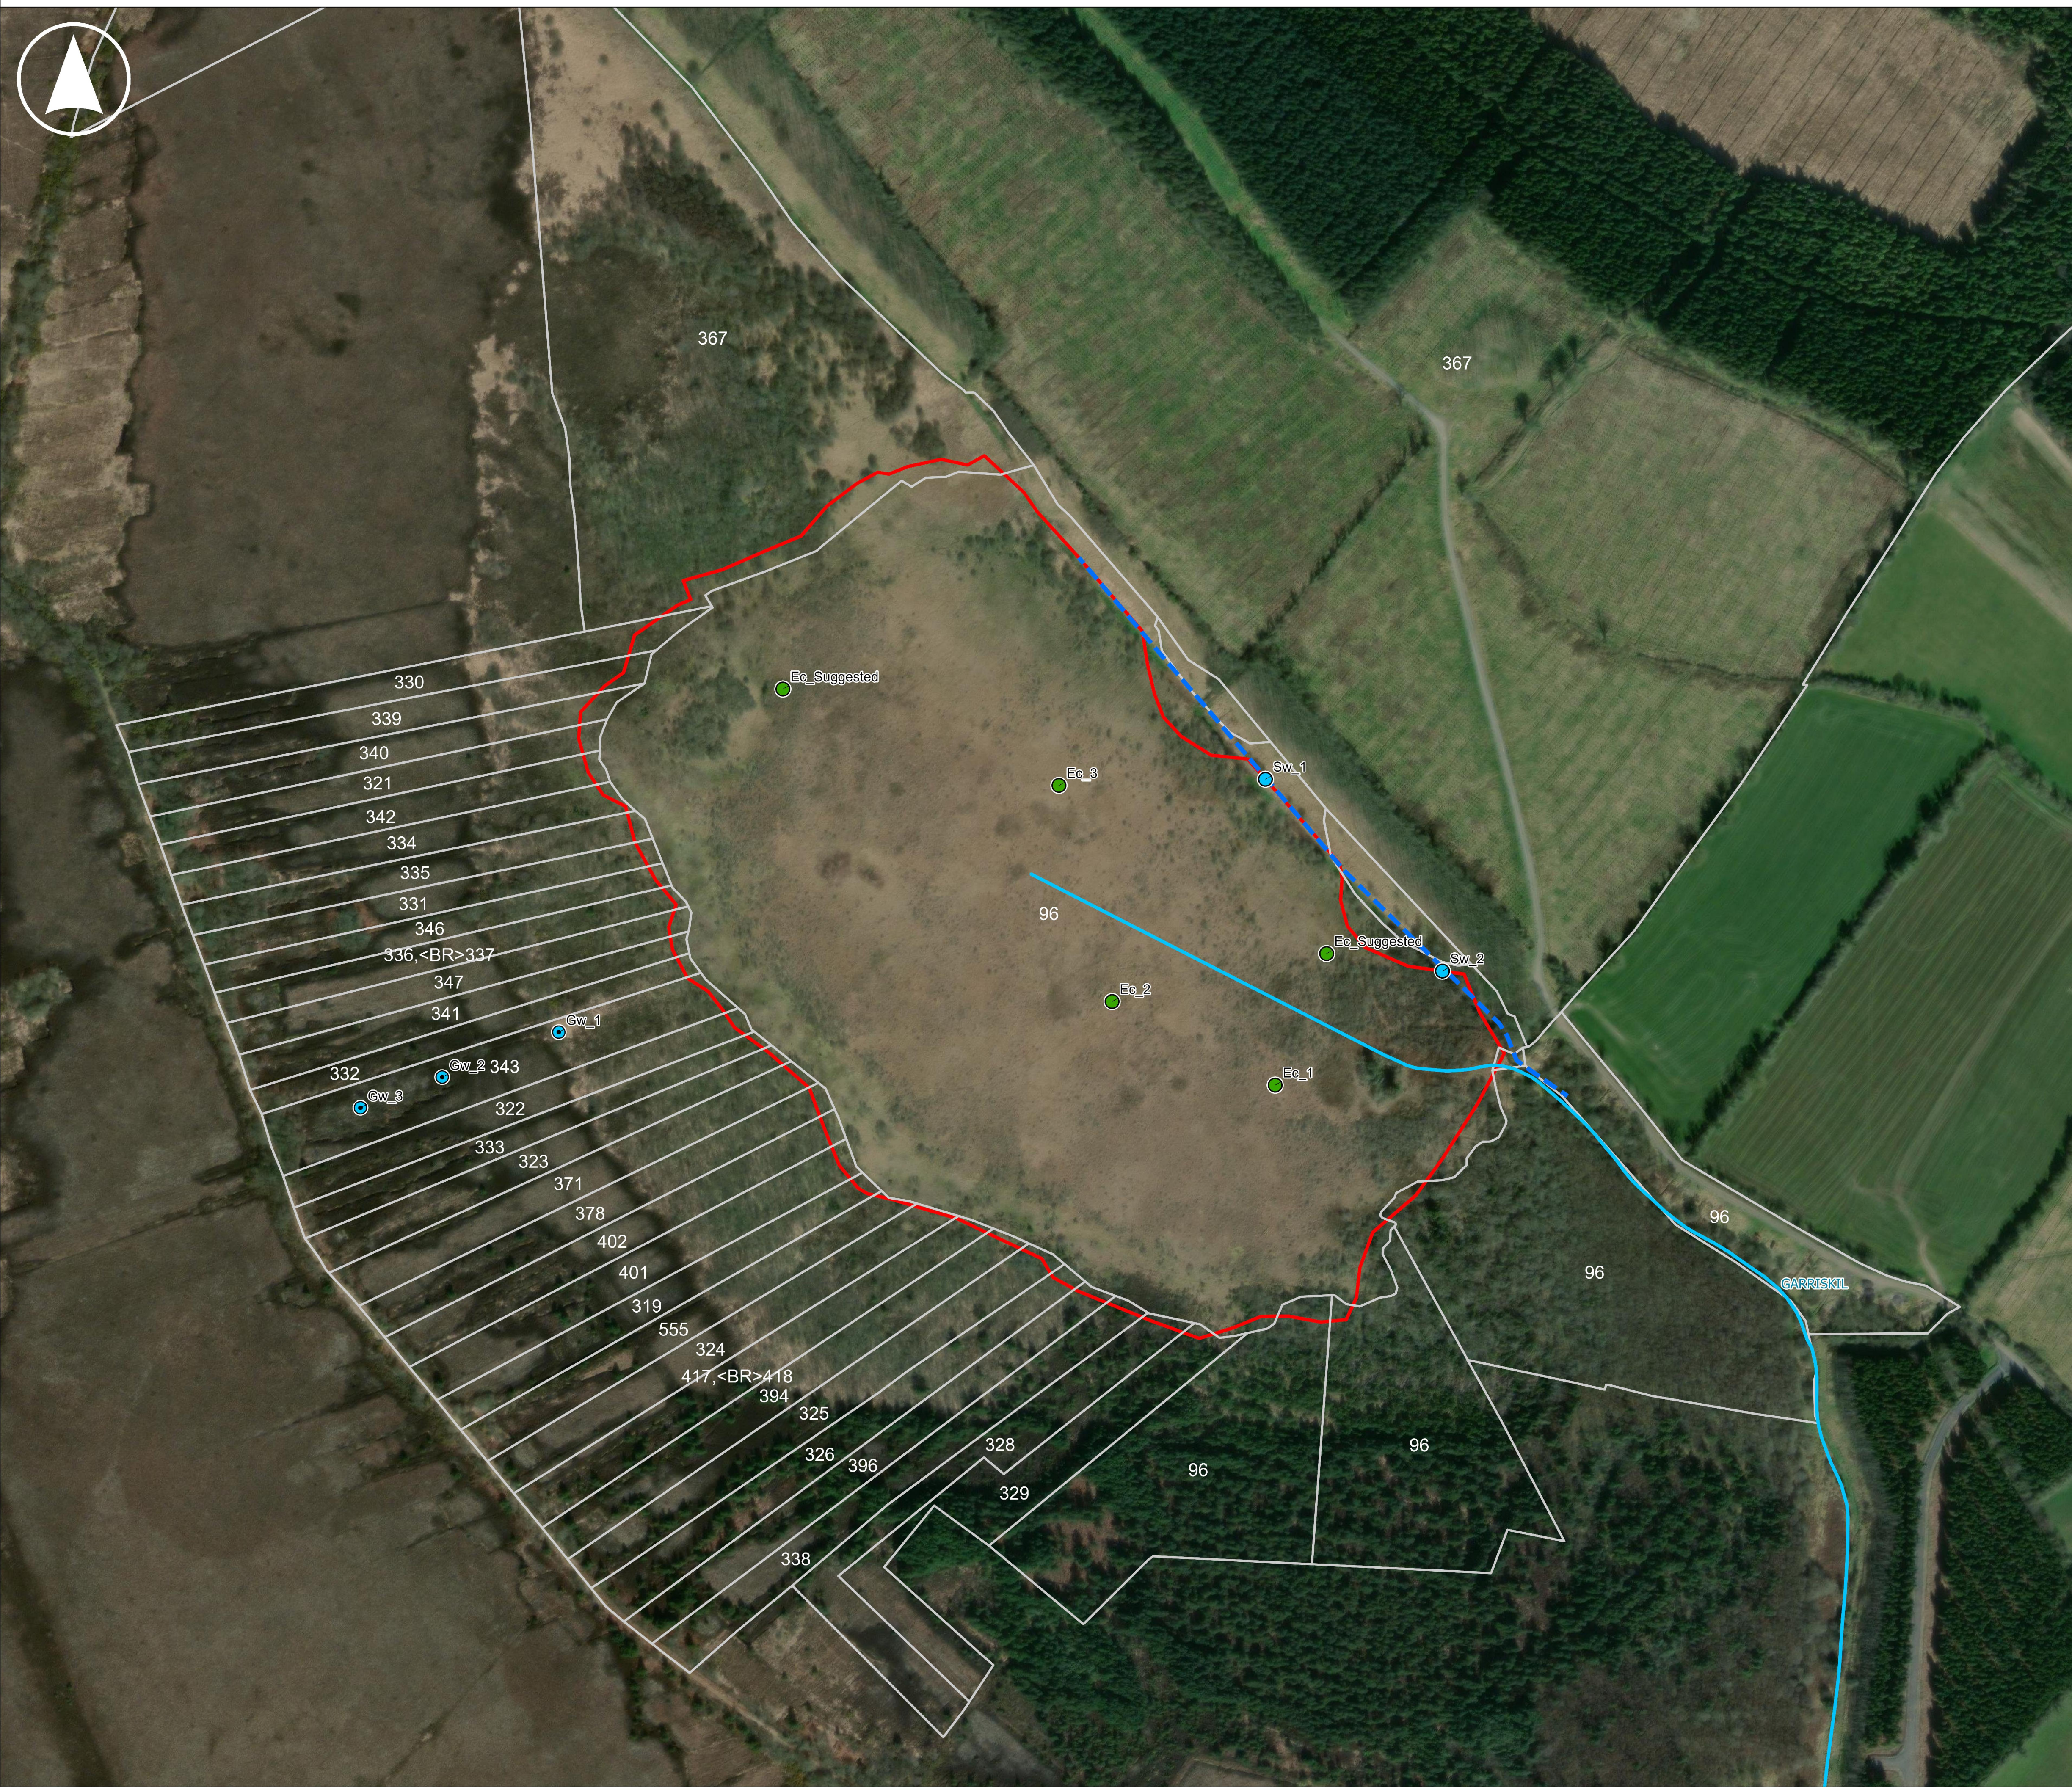
# Fen Restoration - Lough Garr - Phase 1

- Legend**
- Site Boundary
  - Drains
  - Water River Network (OSI)
  - Land Parcels
- Monitoring**
- Ecology monitoring
  - Groundwater monitoring
  - Surfacewater monitoring
