National Parks & Wildlife Service  
Tóchar Midlands Wetland Restoration Scheme

Scragh Bog  
PFS Site No. 1002  
SAC (000692)

**Fen Restoration Plan**

April 2026

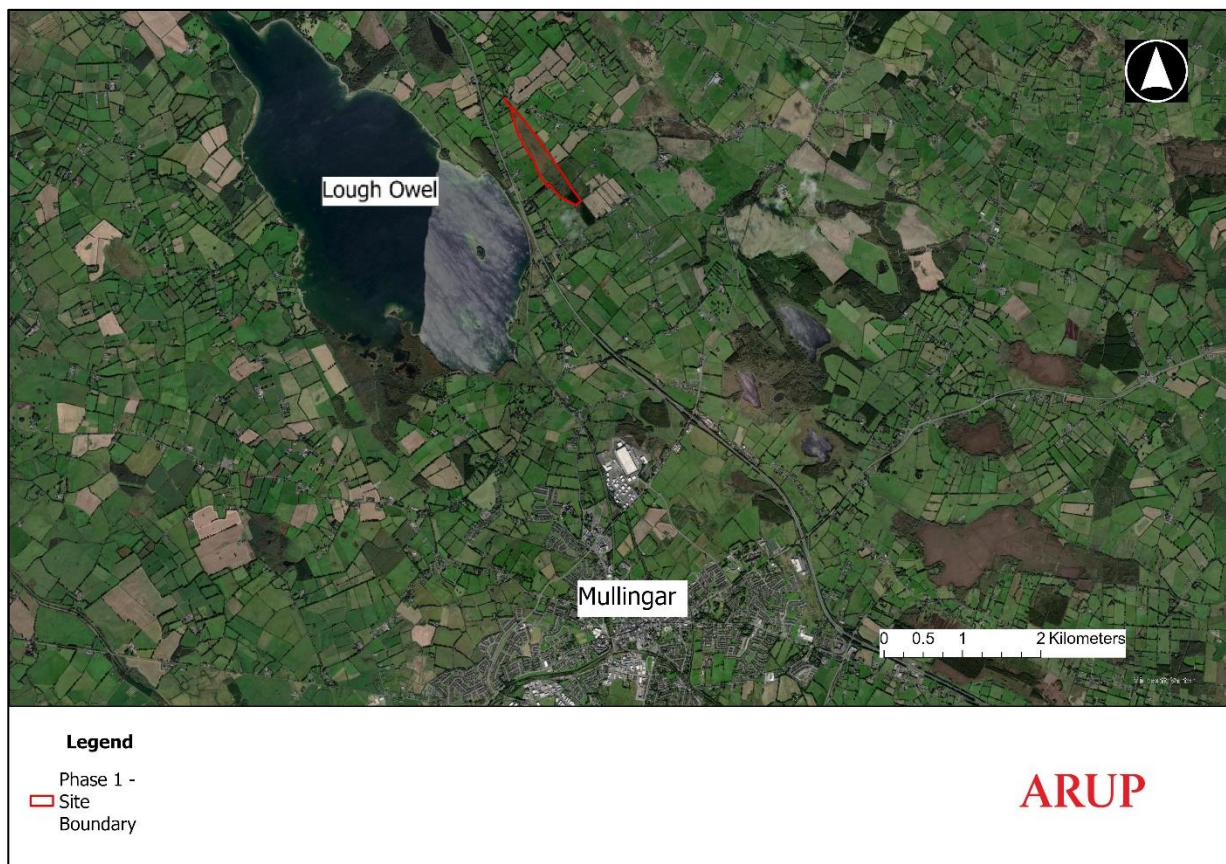
**Figure 2-1: Site location map**

The site sits in a depression at an elevation below 110mOD. A low ridge (120mOD) to the southwest separates the site from Lough Owel. To the northeast the land rises slightly and then slopes towards the River Gaine (70mOD).

Scragh Bog is located 10km north-west of Mullingar (Figure 2-1) The site is bounded to the east and west by agricultural land. Lough Owel lies to the west of the site and is used for drinking water and recreational uses.

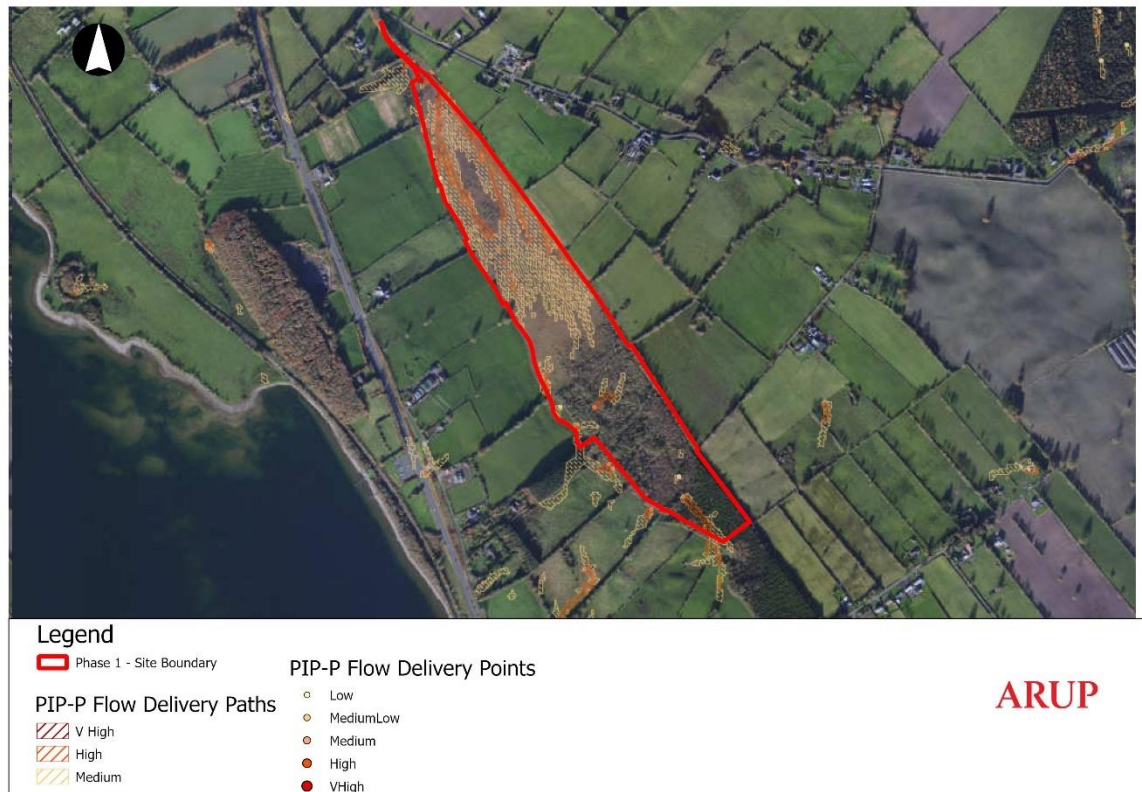
**Figure 3-15: PIP- P - Flow delivery paths and points for Phosphorus for Scragh Bog (EPA, 2021)**

High risk areas for phosphorus loss typically have poorly draining soils and dominant overland flow pathways. The maps indicate that phosphorus delivery flow paths across the site range from medium to high risk in the northern area of the site. The land directly adjacent to the northeastern boundary of the site is classified as high risk from phosphorus runoff.

Freely draining soils and substantial groundwater pathways are high risk for nitrogen losses. Similar to phosphorus, the northeastern boundary of the site is classified as highest risk.

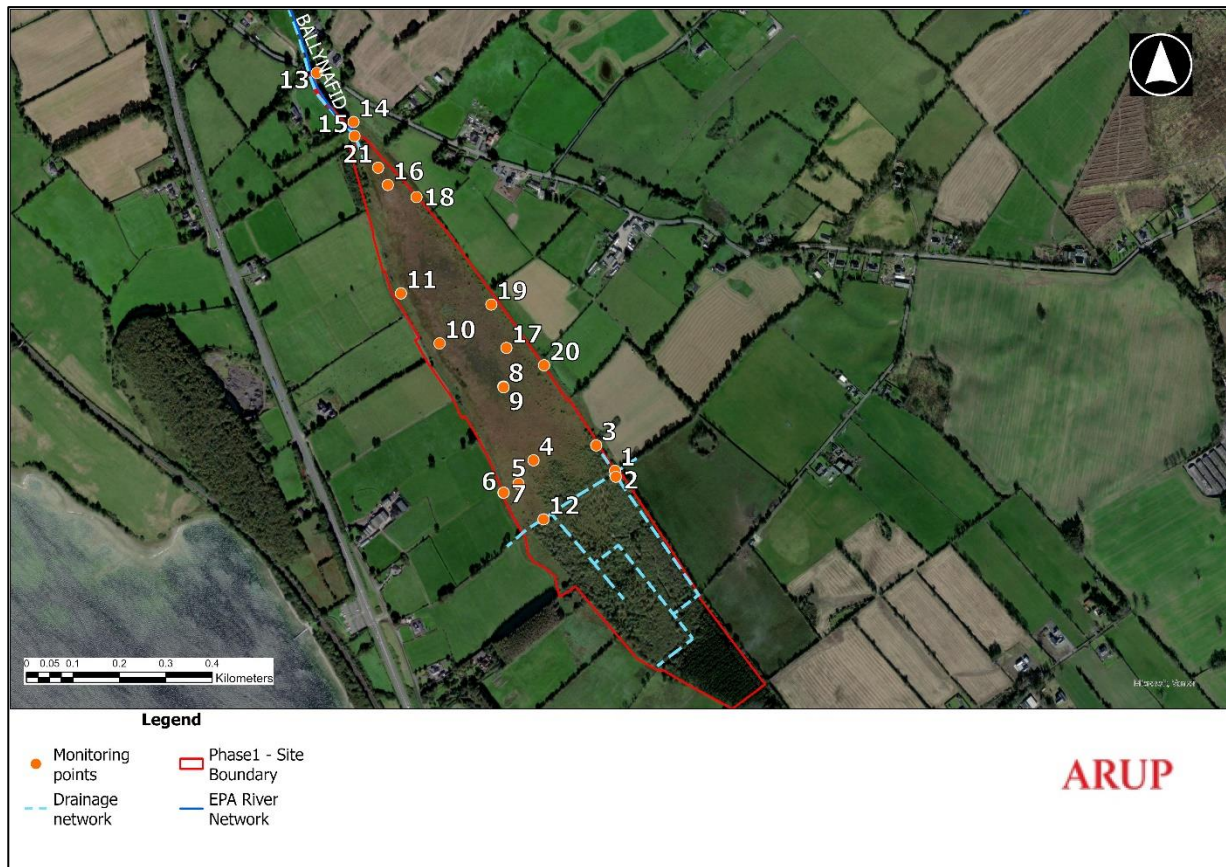
**Figure 3-20: Baseline monitoring locations for Scragh Bog**

Site monitoring was undertaken in August and September 2025, focusing on developing the understanding of the water regime, pressures, and implementation of restoration measures within the site. The site monitoring included peat depth probing, water quality monitoring, groundwater level monitoring in piezometers and observations of water flow in the drainage network (Figure 3-20). Water quality data was collected across multiple points within the site, including fens habitats and the outflow watercourse. The parameters recorded included pH, electrical conductivity (EC), temperature, dissolved oxygen (DO), nitrate (NO<sub>3</sub>-N), and phosphate (PO<sub>4</sub>). Groundwater levels were monitored in selected piezometers, and peat depths were probed to assess substrate characteristics.

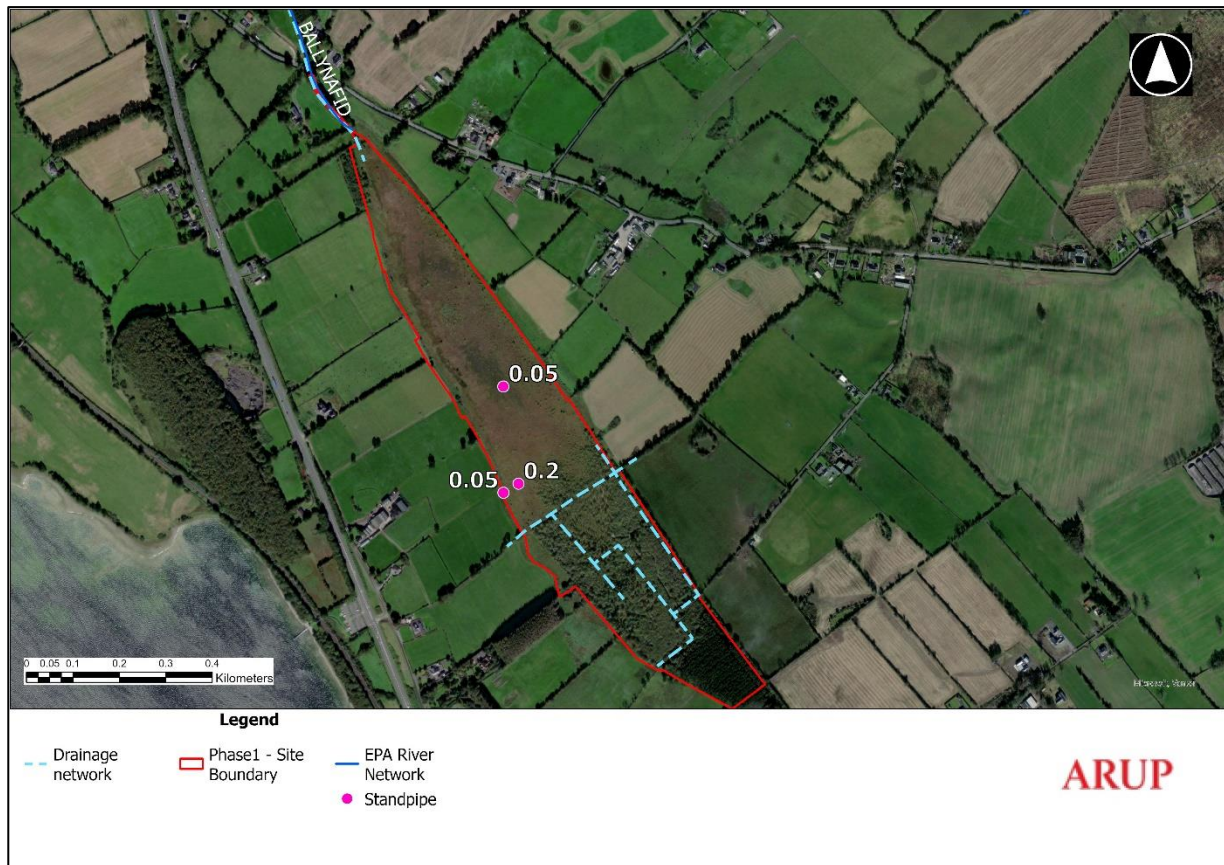
**Figure 3-22: Water depth measurements (m) at Scragh Bog**

Groundwater conditions were assessed in existing piezometers present on site (Figure 3-22). Groundwater levels ranged from 0.05 mbgl to 0.20 mbgl.

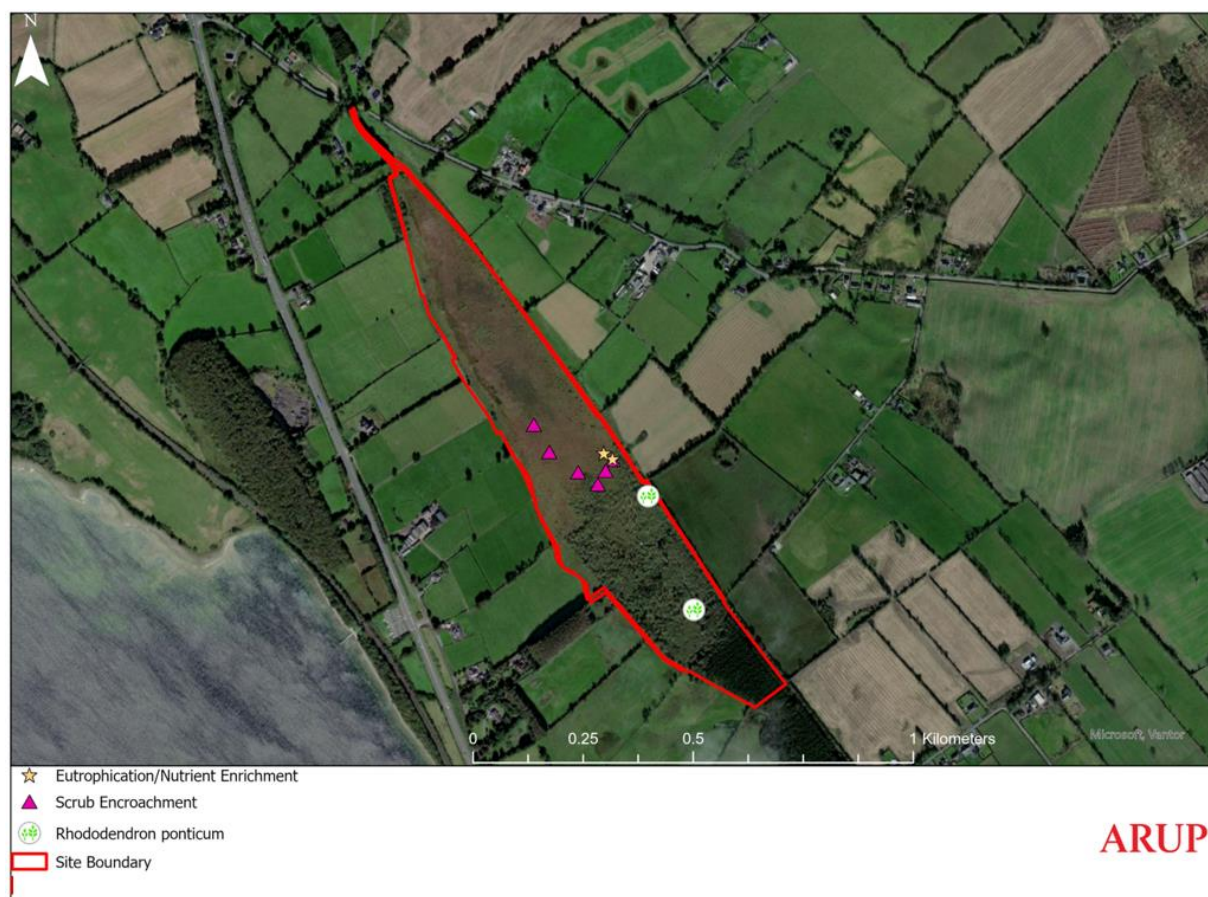
**Figure 5-1: Locations identified as exerting pressures upon the habitats of Scragh Bog**

- Drainage – Historical maps show drains running through Coillte land in the southern area of the site, though these were shown not to be impacting the condition of fen habitat within the site during the 2025 walkover. The 2025 walkover did note that a drain southeast of the open transition mire was starting to infill with vegetation and could be a source of the scrub encroachment.

All identified pressures and threats, whether historical or currently observed, have been fully considered within the FRP to guide appropriate remediation. The proposed suite of restoration measures, encompassing both hydrological and vegetation interventions, is designed to maintain and improve the condition of Annex I habitats present within Scragh Bog, while delivering co-benefits to associated non-Annex habitats and protected species. The prioritisation of pressures (scrub encroachment and nutrient enrichment) was informed by a review of historical data (including the PFS) and detailed observations recorded at monitoring points during this project. These measures, supported by ongoing vegetation and hydrological monitoring, will contribute to the preservation of habitat structure and function, promptly address threats, and help to safeguard the ecological integrity of the site into the future.

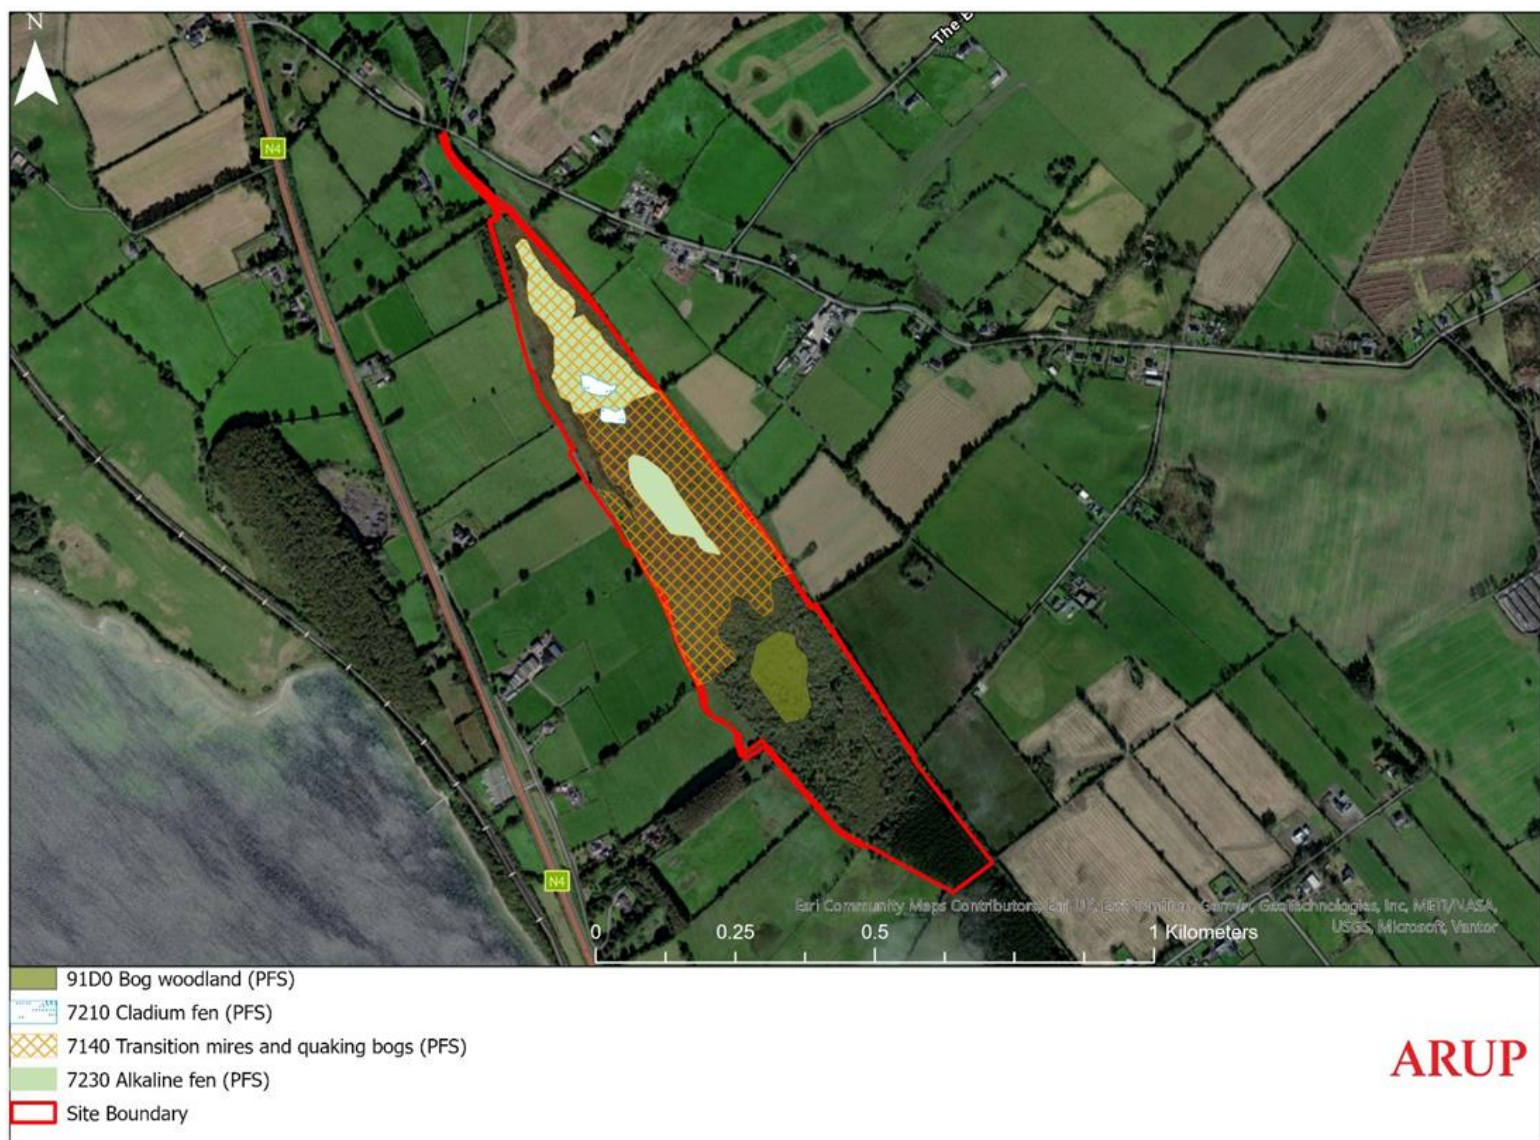
Figure 1: Site Habitat Map

| NPWS Tóchar Midlands Wetland Restoration Scheme<br>Fen Restoration Plan Non-Technical Summary | | | |
|---|---|---|---|
| <p>Scragh Bog is an oval depression containing wet transition fen with a floating root mat located approximately 10km north-west of Mullingar in Co. Westmeath. Much of the site is also part of the Scragh Bog Special Area of Conservation (SAC) for the presence of 7140 Transition mires, 7230 Alkaline fens and 1393 Slender Green Feathermoss. Small pockets of 7210 <i>Cladium</i> fen are also present within the site. The fen habitats are found in the northern part of the fen and bog woodland is located in the southern area of the site. Figure 1 presents the habitats mapped within the site.</p> | | | |

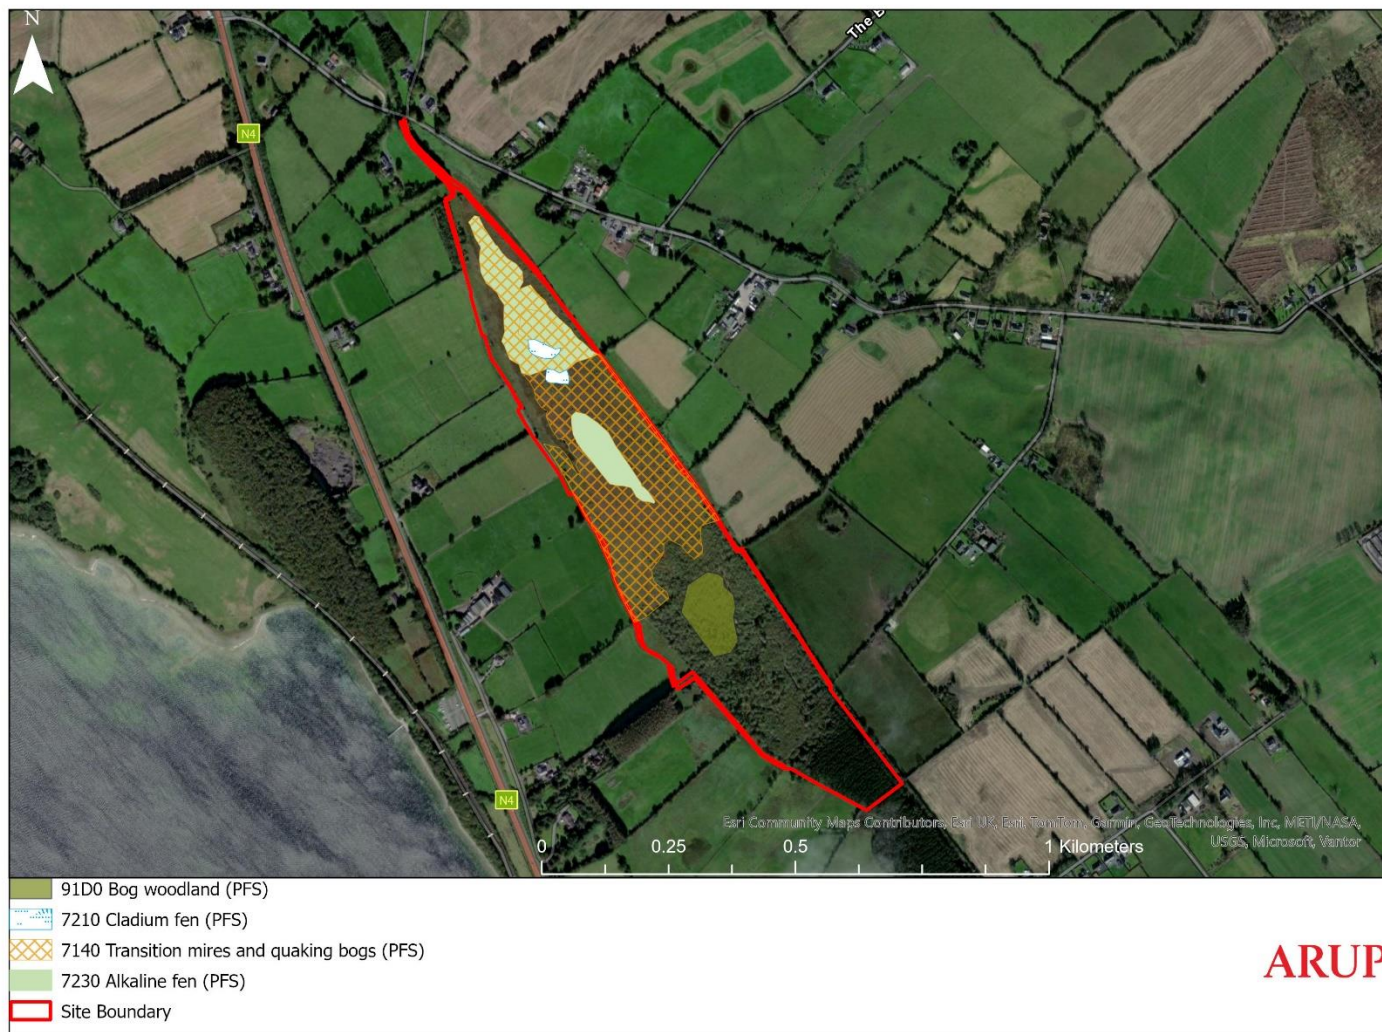
**Figure B.1: Annex habitats recorded during the PFS. Habitats mapped were noted to occur in mosaic with one another.**

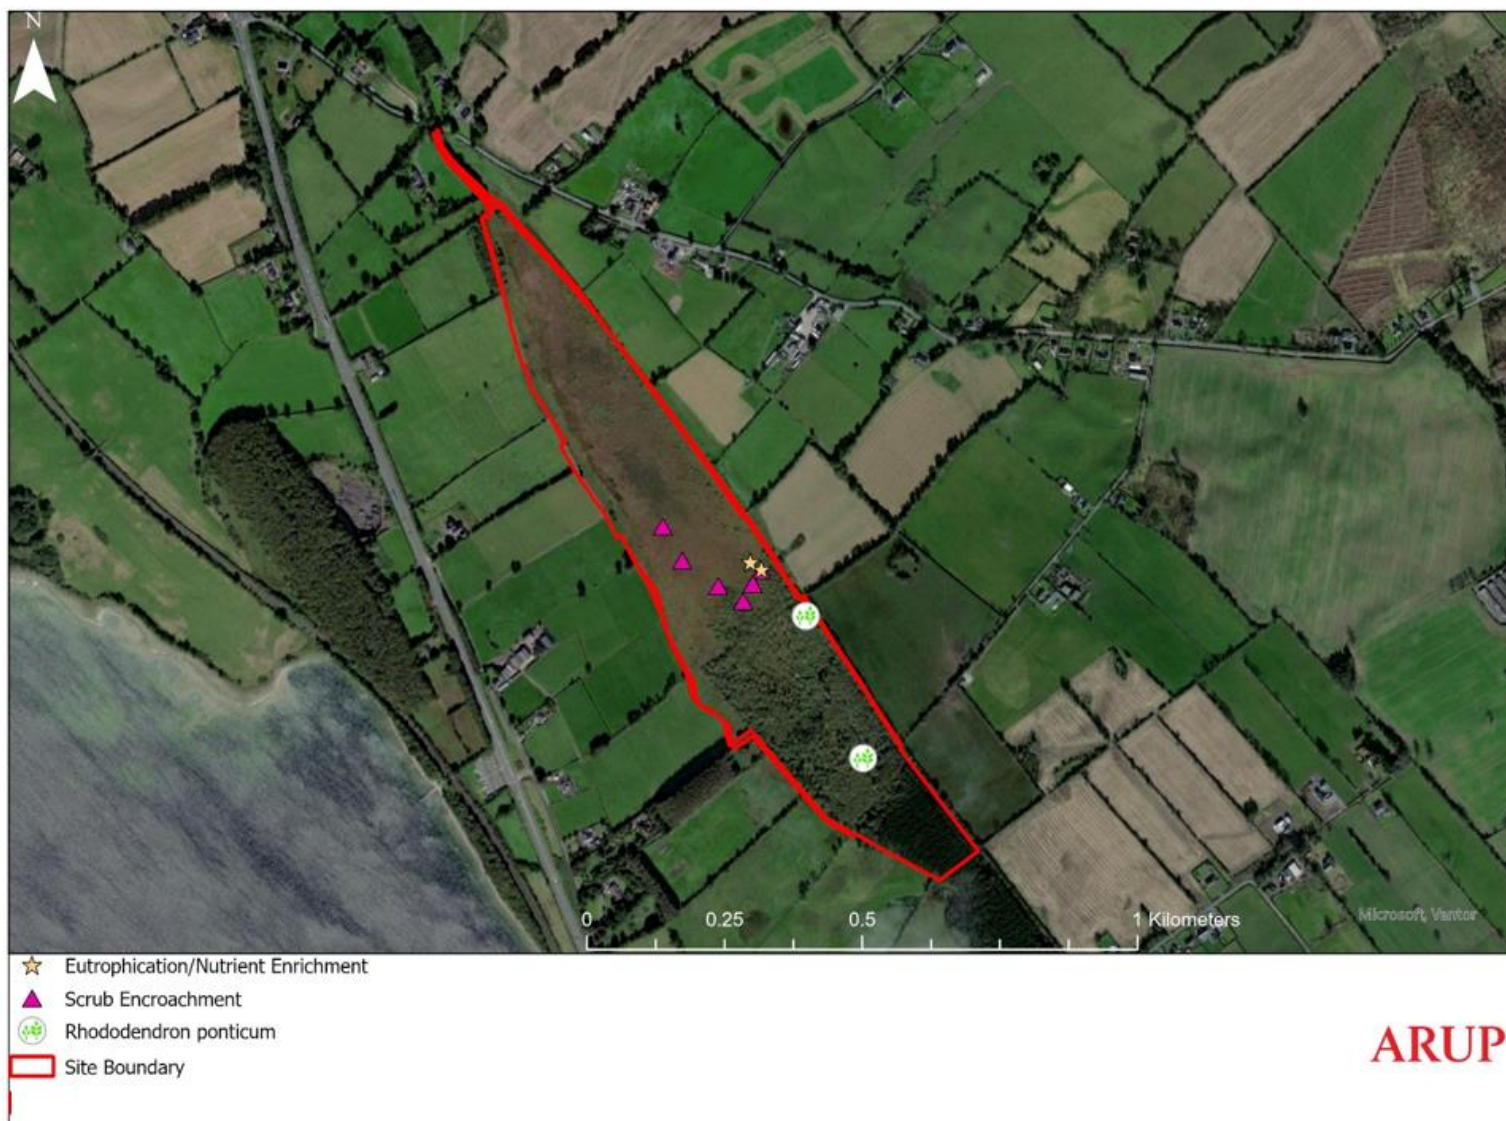
Figure B.3: Pressures and Threats recorded on site at Scragh Bog (identified through desktop review and walkover visits)

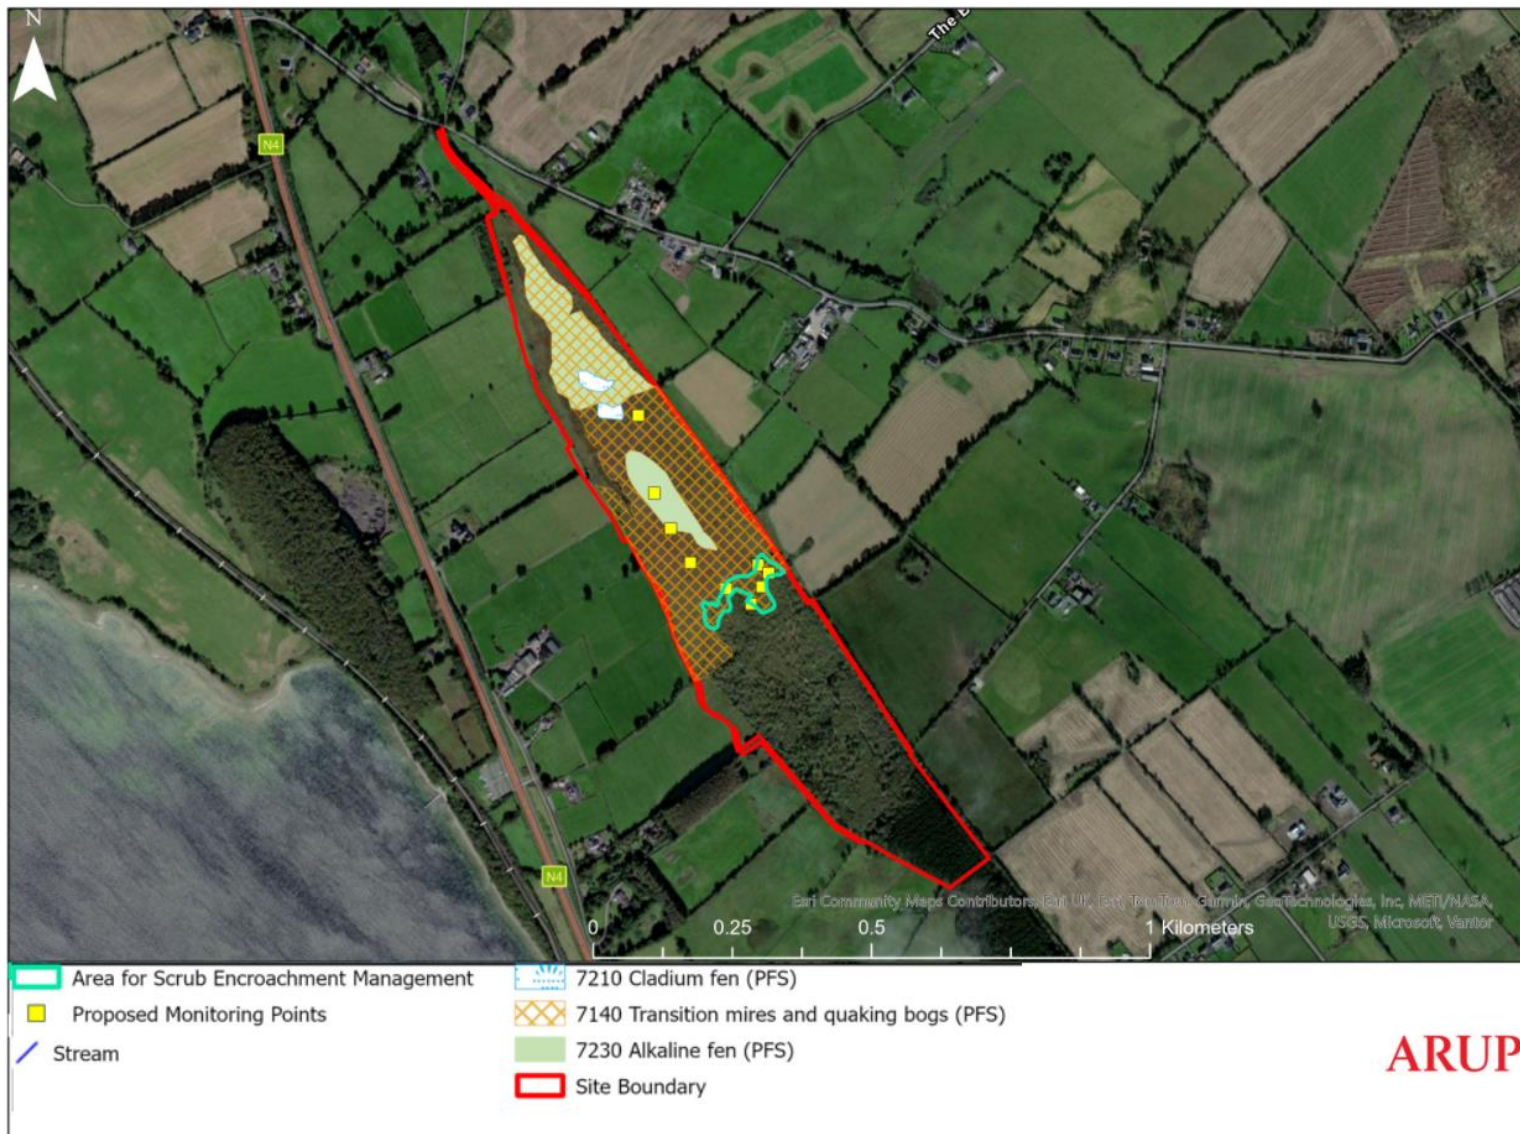
Figure B.4: Restoration measures identified in respect of the habitats and species present at Scragh Bog
